### Development at Symondshyde Farm: Geological Considerations

*This report, dated 13 March 2017, was prepared by Dr Richard Ghail and Dr Philippa Mason at Imperial College London. The authors express no opinion as to the proposed development but only to the ground conditions and potential hazards encountered on site.*

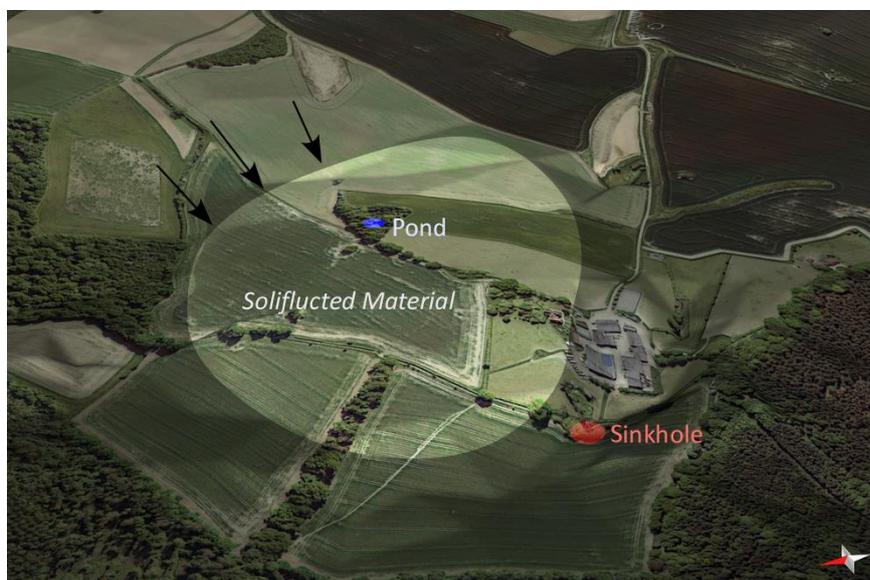
**Figure 1** – Geomorphology of the site. Highlighted area shows potentially soliflucted glacial till. Note the vertical exaggeration is 10 : 1

The geology of the area comprises Lewes Chalk Formation overlain (draped) by glacial till of probable Anglian age (approximately 300,000 to 400,000 year ago). This material was later modified by periglacial solifluction (down-slope slip) in the Devensian (approximately 10,000 to 100,000 years ago), which is most apparent in the geomorphological model of the site (Figure 1). Solifluction strongly shears the fabric of the glacial till and can lead to further, unexpected, slope failure during and after construction.

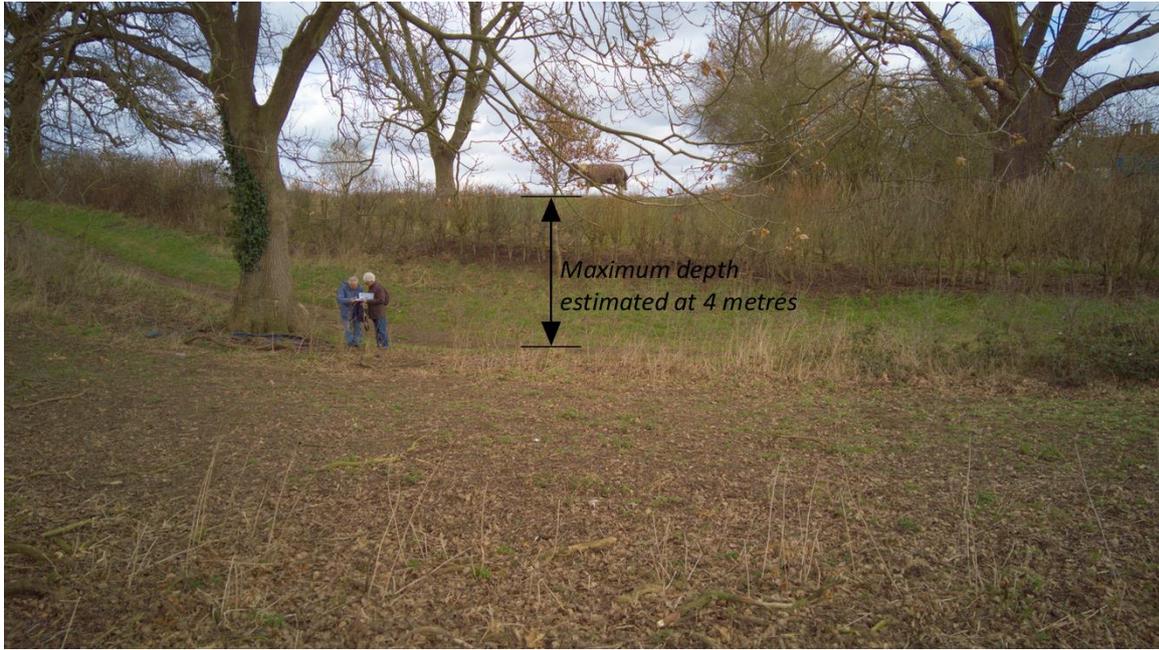
**Figure 2** – Sinkhole encountered near Symondshyde Farm, approximately 12 m wide, 4 m deep.

Chalk is susceptible to dissolution in groundwater, forming a karst landscape consisting of sinkholes, caves and other cavities. The walkover survey of the site clearly identified significant geological hazards including a textbook example of a chalk sinkhole (Figure 2). This sinkhole forms a clear circular hollow in the ground that is dry, while the surrounding ground above the sinkhole is wet, demonstrating that water is draining into the hole at the present time. Any change in drainage across the site, either artificial or as a result of climate change, may lead to collapse of the sinkhole. It should be noted that the recent crown hole collapse that took place in St Albans in October 2015 has been attributed to the existence of ancient chalk mines.

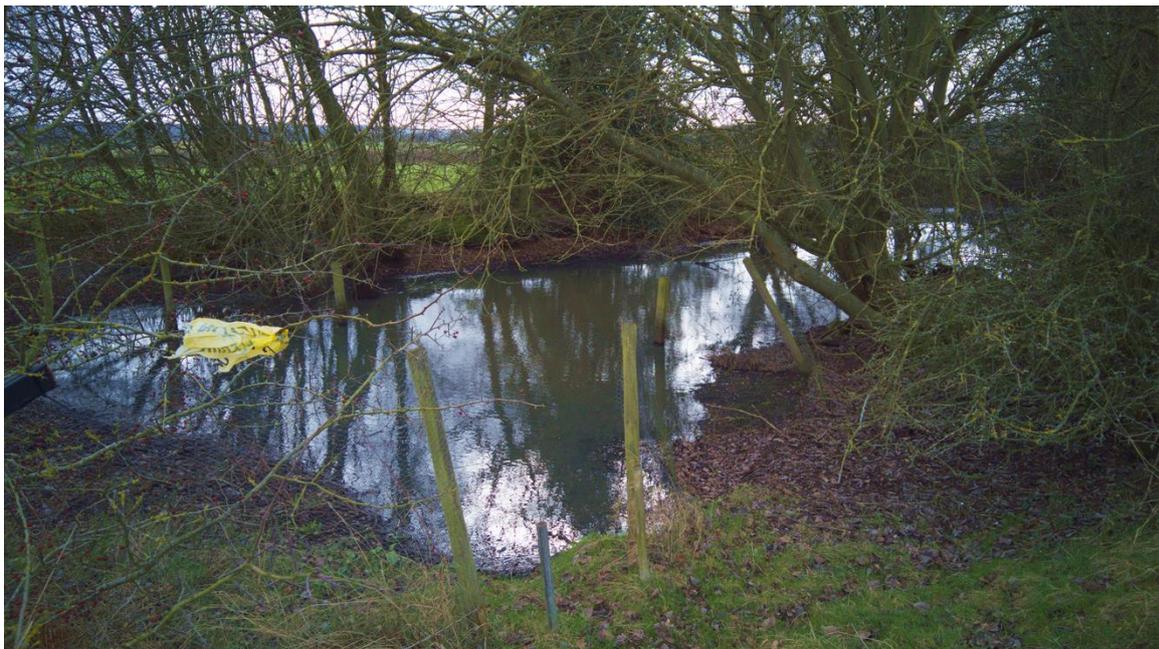
**Figure 3** – Pond encountered near Symondshyde Farm, approximately 18 m x 5 m.

A further probable sinkhole was identified in the form of a pond-filled hollow (Figure 3), the pond indicating that the hollow is blocked at present but again, changes in drainage and rainfall may lead to future collapse. It is noted that gravel extraction takes place in the area and may be responsible for the pond, but the morphology and location are consistent with a sinkhole. A barrow is located close to this pond, indicating that there may be an archaeological interest in the site.
